Manhole Inspection Summary

Manhole # S21A__029MH

Insp Date: **10/18/07 1:03 PM**

Location Address: **1803 HARLEM AVE**

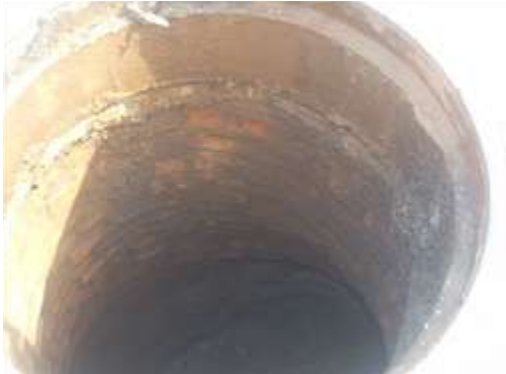
Defect 2

Infiltration: ☐ None ☒ **Joint** ☐ Cracks ☐ Mortar ☐ Roots ☐ Wall

CORBEL INFILTRATION

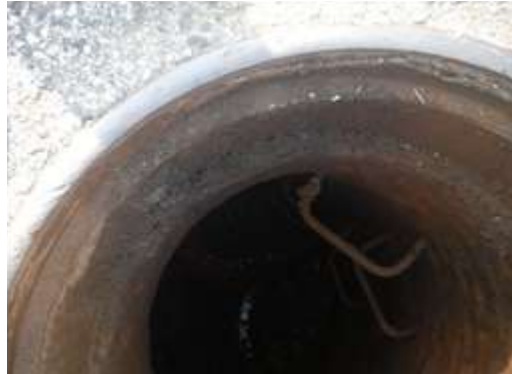
Defect 1

Offset: **1** (in.)

FRAME OFFSET

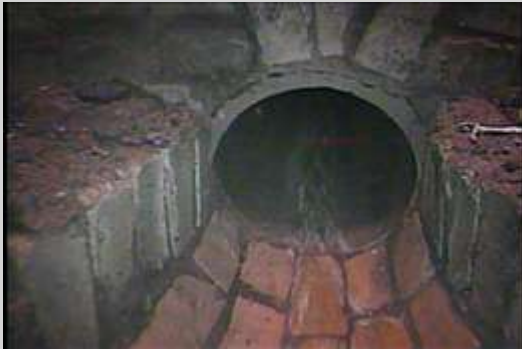
12 O'Clock Outflow

8 in. Circular Gravity Sewer
Pipe Out @ 12 O'Clock

Pipe Height: **8.4** (in.) Rod and Bar (Angled)
Pipe Material: **Clay** ☐ Pipe Lined
Invert Depth: **9.45** (ft.) Flow Characteristics: **Slow**
Deposits: ☒ None ☐ Mud ☐ Sludge ☐ Debris ☐ Grease
Silt Depth: (in.) Deposits Extent:
Infiltration: **None** Pipe Seal Cond: **Sound**

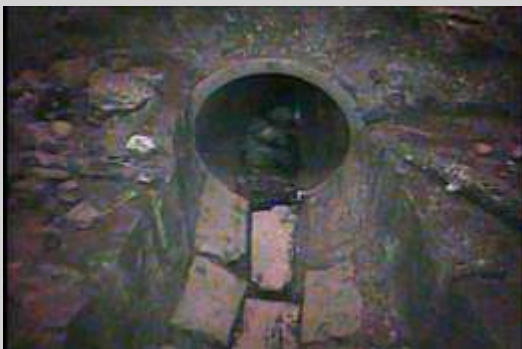
3 O'Clock Inflow

6 in. Circular Gravity Sewer
Pipe In @ 3 O'Clock

Pipe Height: **6** (in.) Rod and Bar (Angled)
Pipe Material: **Clay** ☐ Pipe Lined
Invert Depth: **8.99** (ft.) Flow Characteristics: **None**
Deposits: ☒ None ☐ Mud ☐ Sludge ☐ Debris ☐ Grease
Silt Depth: (in.) Deposits Extent:
Infiltration: **None** Pipe Seal Cond: **Sound**

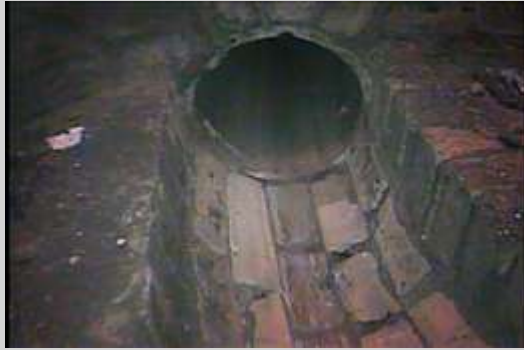
9 O'Clock Inflow

8 in. Circular Gravity Sewer

Pipe In @ 9 O'Clock

Pipe Height: **8.4** (in.) Rod and Bar (Angled)

Infiltration: **None** Pipe Seal Cond: **Sound**
